# Facility Condition Assessment Pentwater Township / Village of Pentwater Offices

Project No. 190609  
May 13, 2019

Fishbeck, Thompson, Carr & Huber, Inc.  
engineers | scientists | architects | constructors

**Prepared For:  
Pentwater Township  
327 North Hancock St.  
Pentwater, MI 49449**

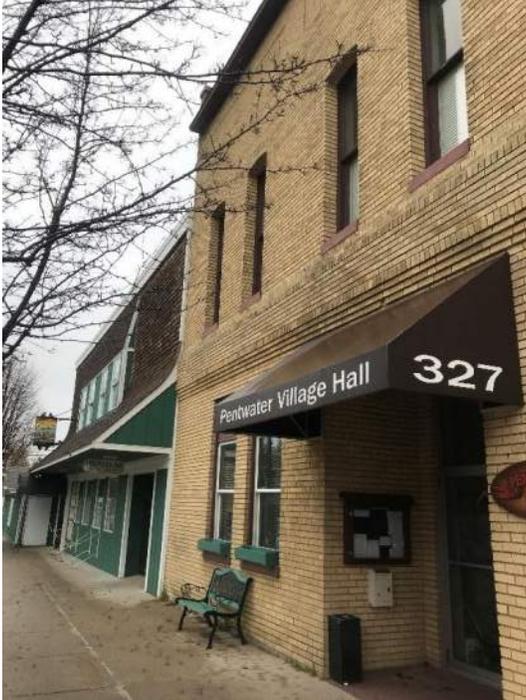
- East wall is in good condition, but brick is soiled. Mortar is in fair to good condition for its age. (Reference Photos A1 and A2).
- Exterior walls show evidence of extensive water infiltration. Brick faces have popped off and portions of brick are missing, especially on the north wall and around the north, west, and south perimeter at the top of the wall. West wall has been covered with metal panel due to falling brick. Metal panel finish is compromised. (Reference Photos A3 - A6).

A1 – Brick façade (East)

- Perform minor tuckpointing of brick on east (front) façade (10%). Clean brick.
- If exterior north, south and west walls are to remain, strip exterior paint, replace compromised brick, ranging from selective repair to full-width replacement. Tuckpoint entire wall and coat with a breathable sealer. Replace coping. Strip plaster and lath from interior. Refer to structural section for more comprehensive study of these walls.

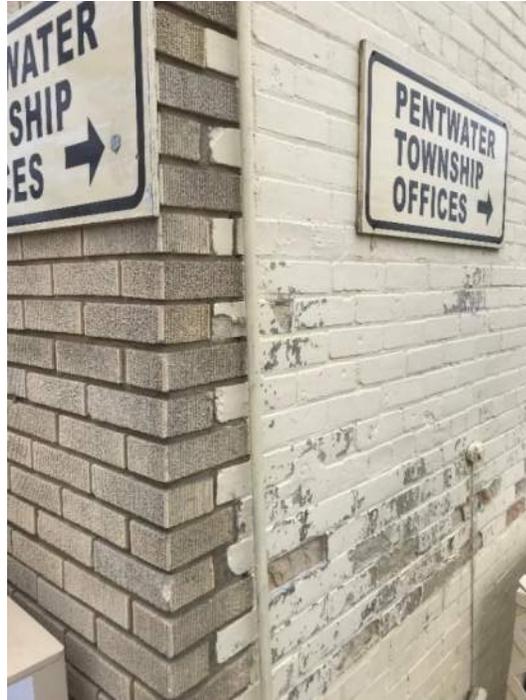
A2 – Brick façade (East and North)

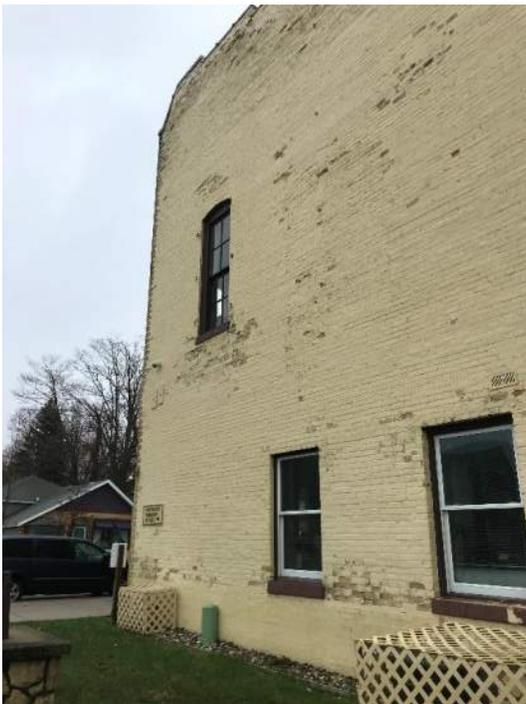
- Painted exterior finish on north, south and west walls act as a vapor barrier and traps water in the walls, which likely contributes to brick faces popping and mortar coming loose. (Reference photos A3 and A6).

A3 – Brick façade (North)

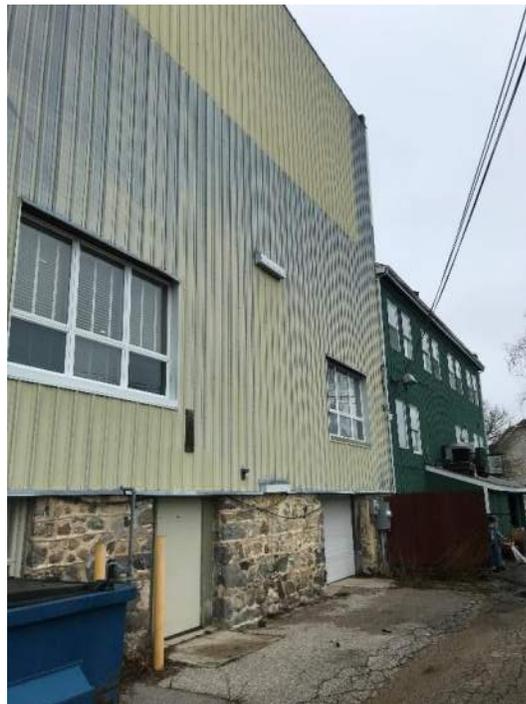
A4 – Brick façade covered in metal panel (West)

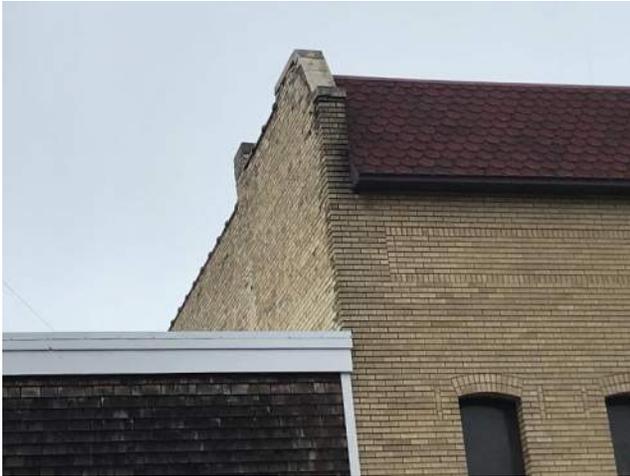
A5 – Brick façade (South)

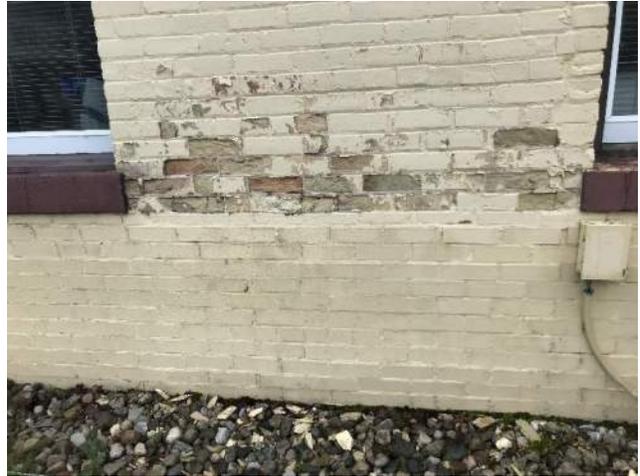
A6 – Brick façade (North)

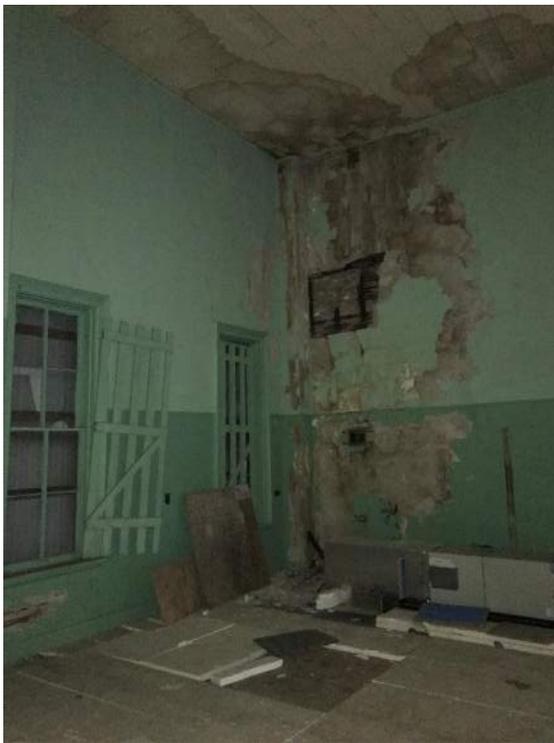
- Second floor plaster wall finish is severely compromised for entire height of wall, especially in northwest corner. (Reference Photo A7). Plaster at entire perimeter of second floor is compromised, wholly or partially. Second floor interior plaster partitions and ceilings are also cracked.

A7 – Northeast corner – Second Floor

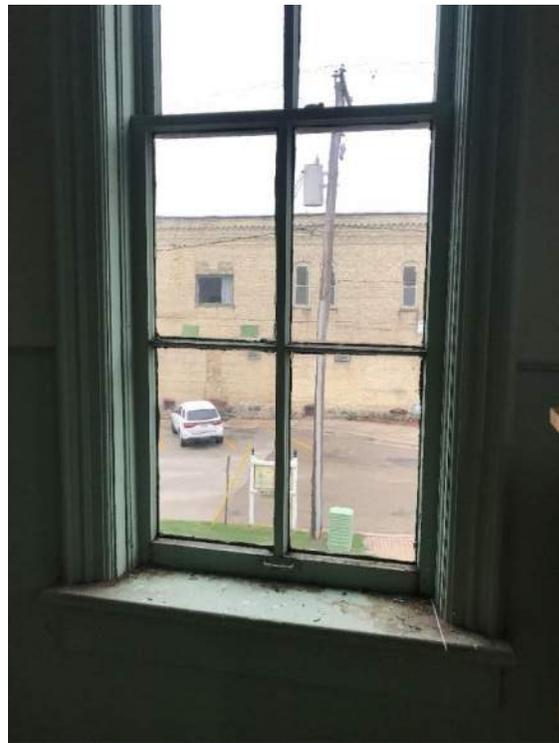
- Second floor windows are not insulated, some glass is broken, and there is evidence of sealant failure and water infiltration. (Reference Photo A8).
- Roof has mild to moderate mineral loss, which is expected for its age. The roof likely has 10-15 years of remaining life, if inspected and maintained properly. (Reference Photo A10).

A8 – Second floor windows

- Replace basement and second floor windows. At first floor windows, repair sills and recaulk entire perimeter.
- Upgrade the size of existing primary roof drains, add drains, and provide a secondary roof drainage system such as overflow drains or through-wall scuppers to minimize the risk of rainwater accumulating on the roof during heavy rainfall events. The accumulation of rainwater on the roof that is possible due to the current inadequacy of roof drainage poses both structural loading problems and water infiltration problems.

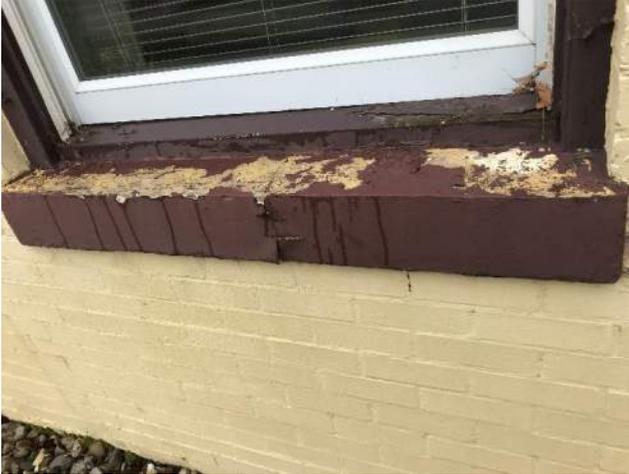
- First floor joists show evidence of past water infiltration. This does not appear to be a continuing problem.
- First floor windows are generally in good condition. Stone sills have been painted. Paint is peeling; sealant has failed. (Reference Photo A9).

A9 – First floor windows / sills

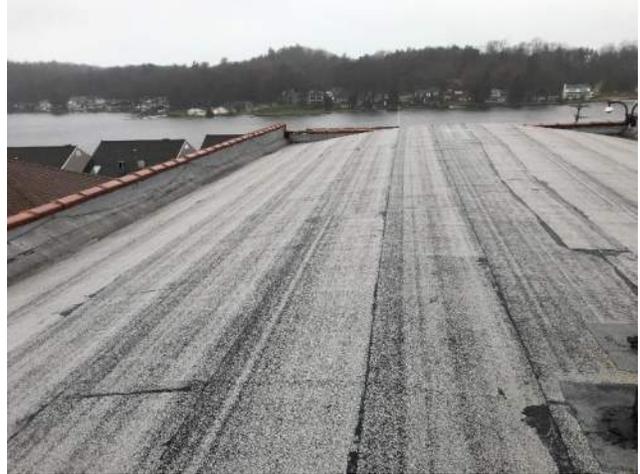
A10 – Roof condition & slope

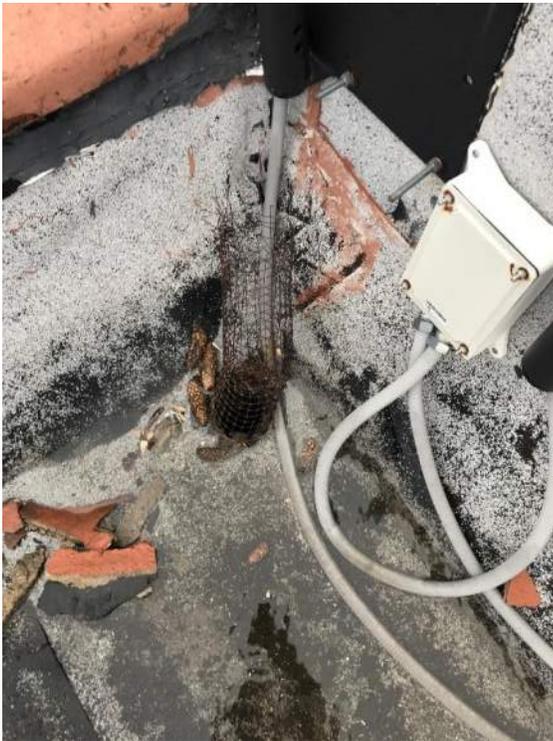
A11 – Northeast roof drain & electrical box

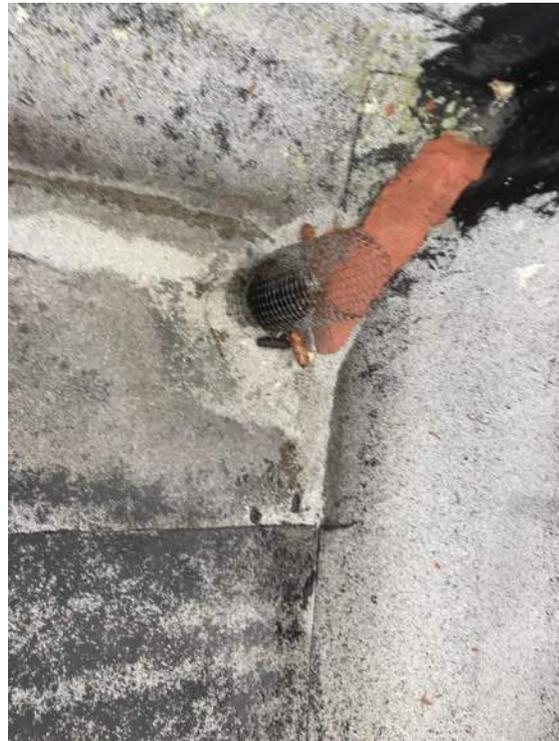
A12 – Southeast roof drain

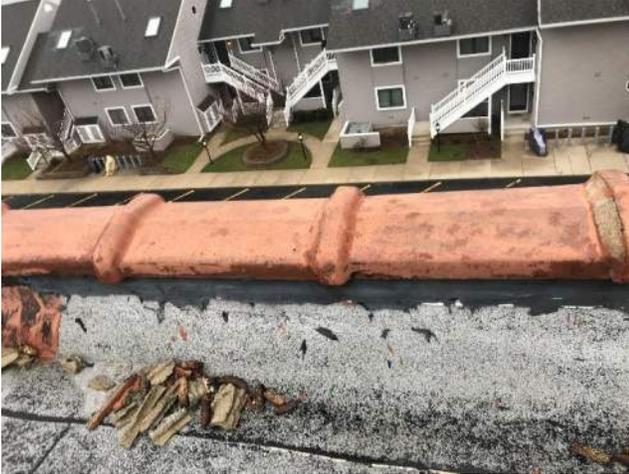
- Roof copings are clay tile, which is degrading and chipping. Sealant joints are compromised, allowing water infiltration into the wall. (Reference Photo A13).

A13 – Roof coping

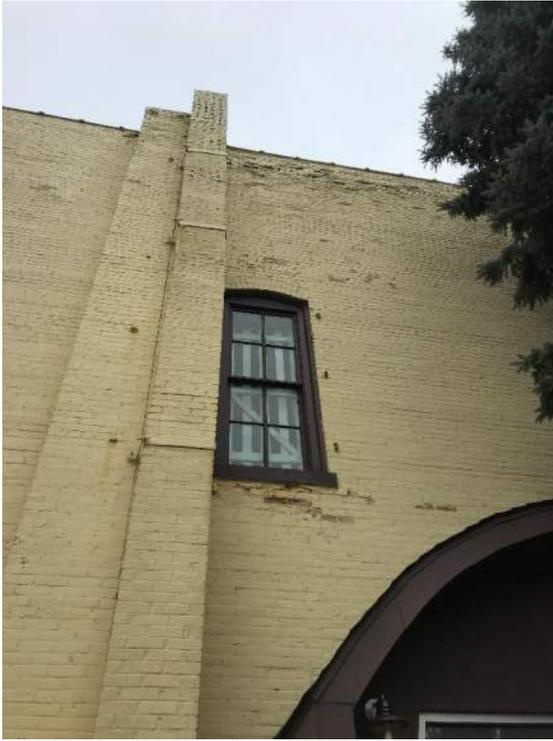
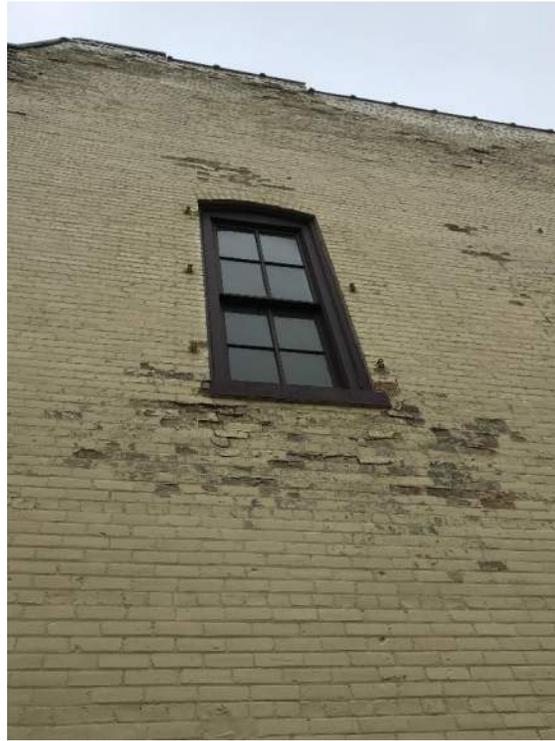
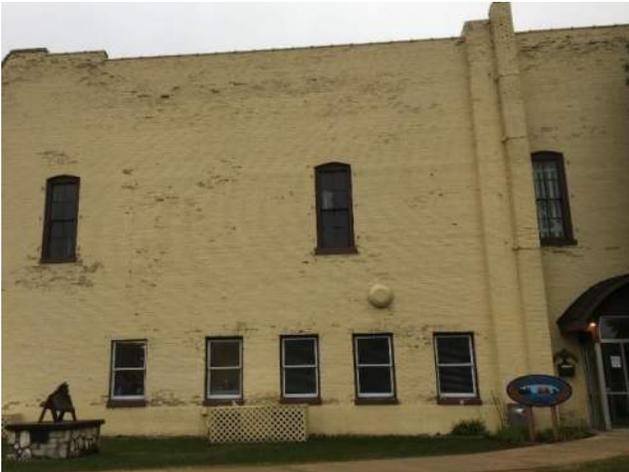
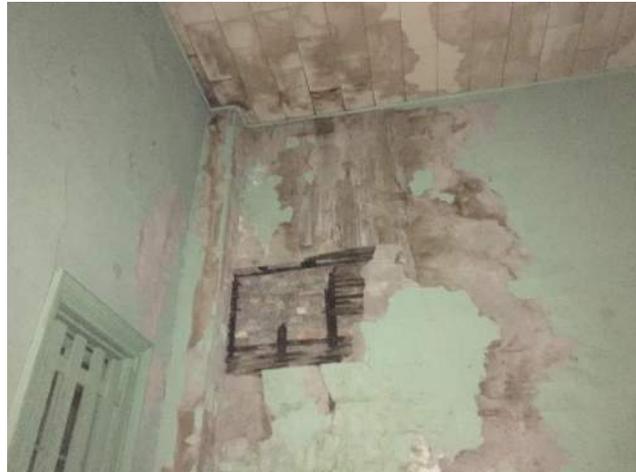
- There is visible deterioration of the north exterior brick wall. The visible deterioration is greatest near the top of the wall on the second floor. The deterioration is visible both on the exterior of the wall and in certain locations on the interior of the wall on the second floor where the lath and plaster has been removed. There is also visible deterioration on the exterior of the north wall around the windows, both on the first floor and second floor. (Reference photos S1 through S4)

S1 – North wall

S2 – North wall

S3 – North wall

S4 – North Wall

- Completely replace in kind the north, west, and south exterior walls above second floor to merely restore them to the integrity of the original construction, prevent further deterioration, and prevent the risk of injury or property damage due to falling brick. It is likely that the building would need to be unoccupied during this work.

- Perform localized repairs to the north and west exterior walls on the first floor, ranging from tuck pointing to full-thickness replacement, in areas where there is deterioration. Engage a mason experienced in the repair of old brick structures. Interior finishes may need to be removed to perform these repairs.

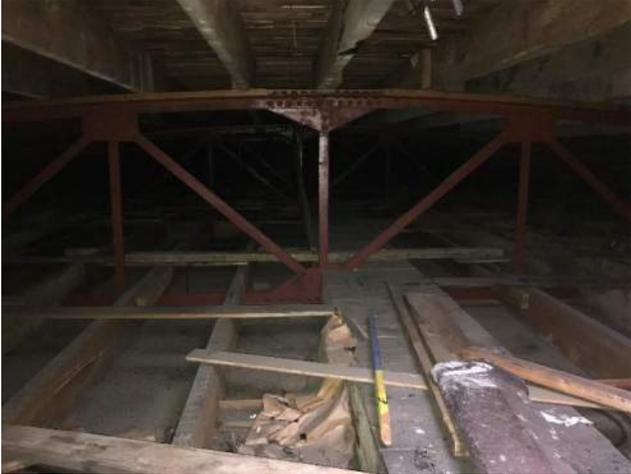
S5 – Bowstring trusses

- A replacement of the roof structure may be necessary for the roof to resist loading required by the current building code. Required replacement would likely include the steel trusses, wood roof and ceiling joists, and wood roof decking.

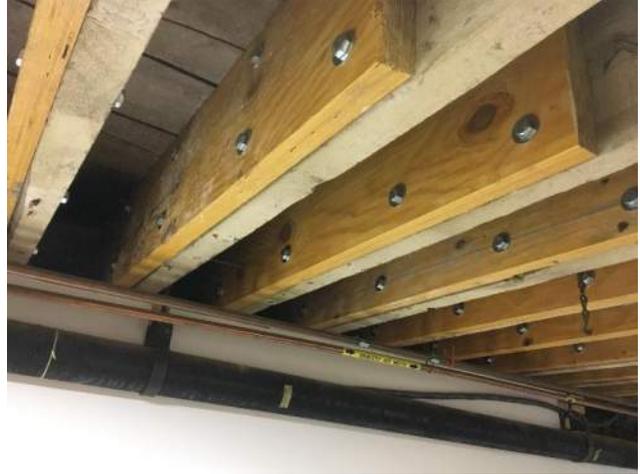
S6 – Repaired joist ends

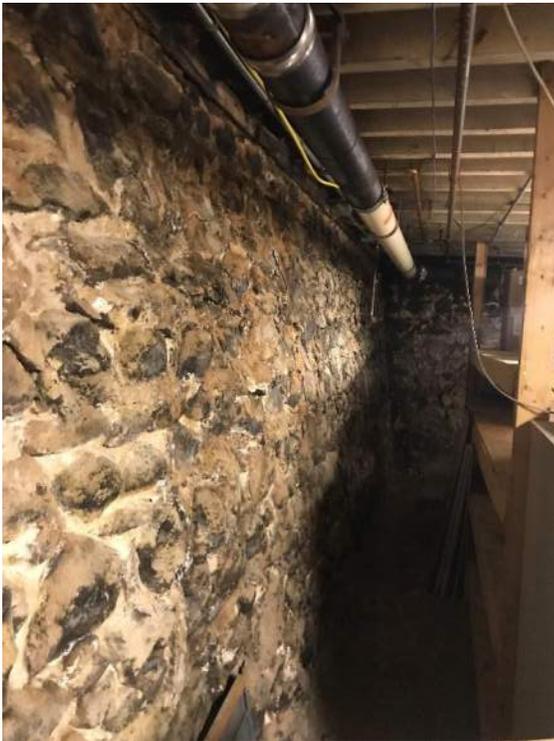
- Basement foundation walls are rubble stone masonry. In most locations inside the basement where the rubble stone walls are visible, there is deteriorated stone and mortar accumulated at the base of the wall. (Reference Photos S7 and S8). The deterioration of the of the walls is likely accelerated by moisture. Moisture may be coming from contact with the ground on the exterior side of the wall, from water infiltration into the walls above, or a combination of both.

S7 – Rubble foundation wall

- Perform repairs to the mortar and stone on the interior face of the rubble stone foundation walls. Engage a mason experienced in the repair of stone masonry foundations.

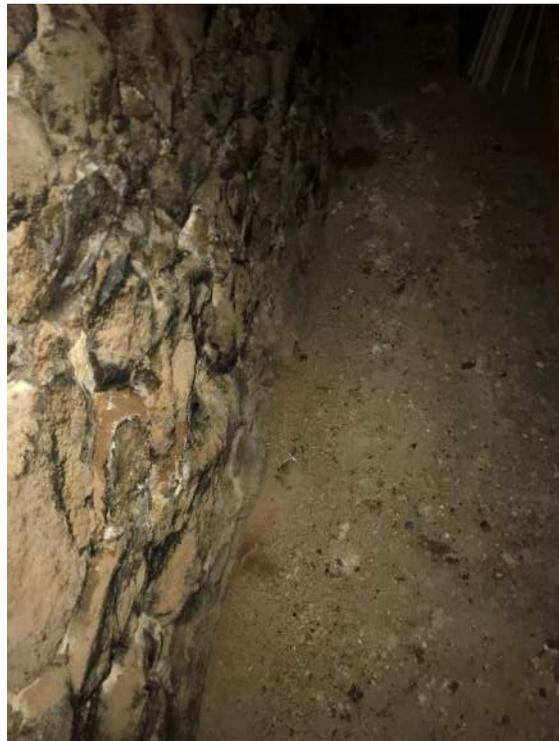
- In 2003 FTCH observed significant deterioration of the first-floor joists where they bear on the north foundation wall and significant deterioration of the wood sill plate supporting the joist ends on top of the foundation wall. It was suggested that the deterioration was caused by insect damage, moisture, or a combination of both. Sketches illustrating repair methods were provided by FTCH at that time. These repairs have been made in some locations along the north exterior wall. (Reference Photo S8).

S8 – Rubble foundation wall

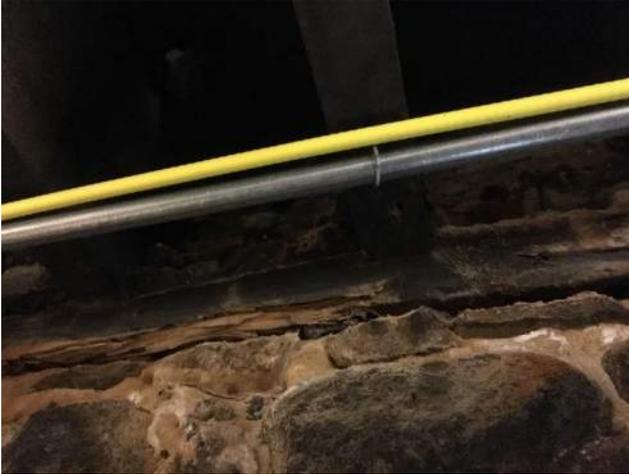
- The deteriorated joist and sill plate conditions described in FTCH's 2003 letter are present in other locations along the north wall where the recommended repairs have not been made. The most noticeable areas of deteriorated sill plate and joist ends is near the east end of the building, along the north wall. (Reference Photo S9). Note that there may be other areas suffering from similarly deteriorated sill plates and joist ends that are not visible due to wall and ceiling finishes covering them.

S9 – Rotten sill joist end

- Remove the exterior chimney on the north wall that is visibly out-of-plumb.
- Repair first floor joists that are deteriorated where they bear on the exterior foundation walls. Repairs would be similar to those recommended by FTCH following the 2003 assessment.

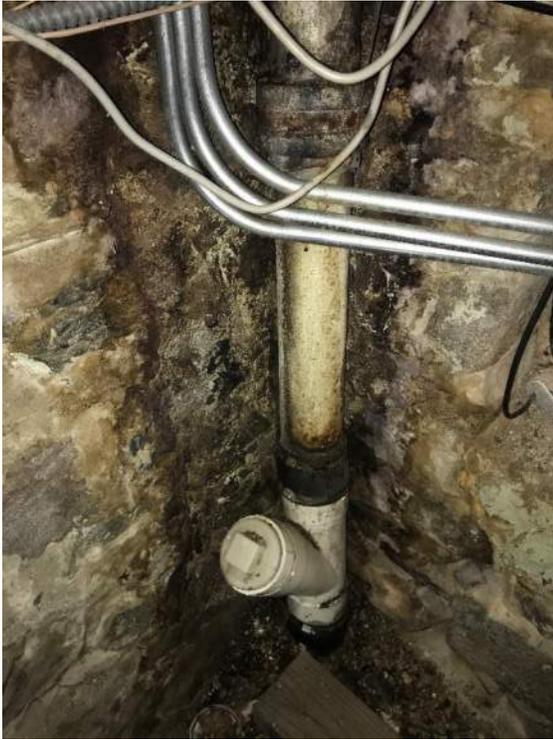
M1 – Leaking roof drain – Southwest corner

- Repair leaking drainage pipe at the building SW corner at the lower level. (Reference Photo M1).
- If the upper level is to be occupied, new bathrooms will be necessary. Main level plumbing revisions will also likely be necessary depending on the extent of renovation.

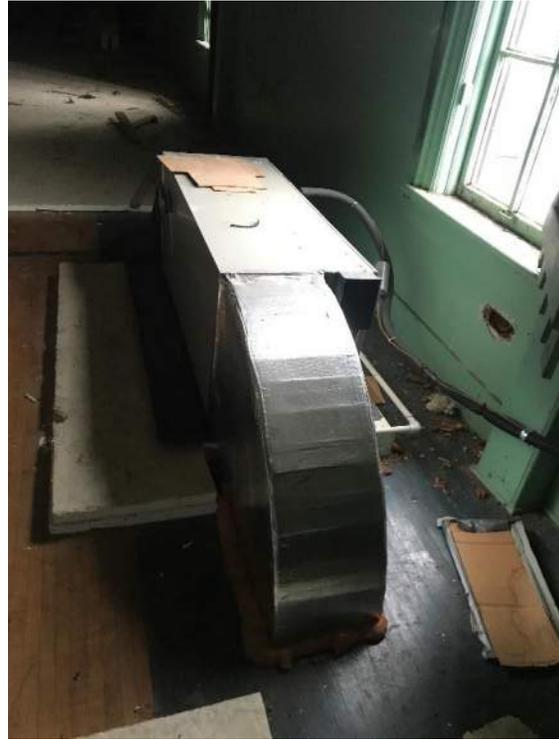
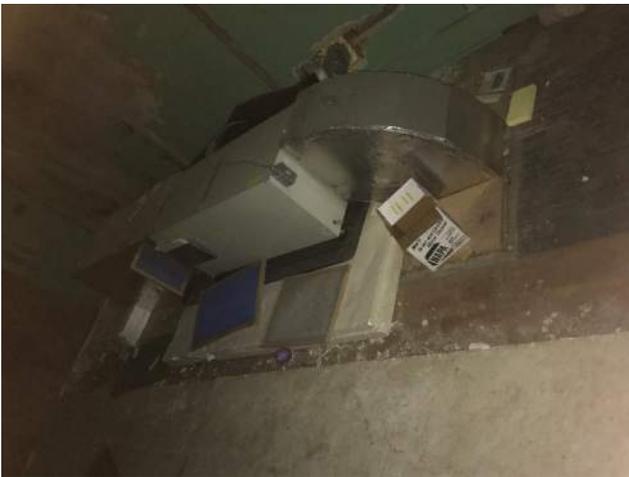
- There are three small air handlers (AH) located on the floor of the second level along the North wall. These AH's serve the three first floor areas (west end area, center area, east end area – Reference Photos M2 and M3). Each has an air-cooled condensing unit located on grade along the north wall with refrigerant piping routed up to a cooling coil in the AH's. This equipment appears to be in fairly good condition. The AH serving the center area of the main floor may have an electric heater in it also. Air is distributed from the AH's through supply and return ductwork located above the ceilings of the main level to ceiling mounted diffusers and grilles. Simple electric thermostats control the AH's. An electric steam humidifier located in the basement boiler room is connected to the AH system serving the first-floor west end. It is uncertain if it is functioning. The first-floor west end AH appeared to have some fresh outdoor air ducted to it from a north wall-mounted intake hood. It is uncertain if the other two AH's have the code required outdoor air supplied to them.

M2 – Air Handler

M3 – Air Handler

- Main Level: The three AH's will need to be replaced to free up the floor space of the upper level. The associated grade mounted condensing units will also need to be replaced because it is likely they will not be the right size for the revised main floor plan and they are using R22 refrigerant which is no longer code compliant for new projects. Some of the existing ductwork and diffusers and grilles may be reused, depending on the new floor plan layout.

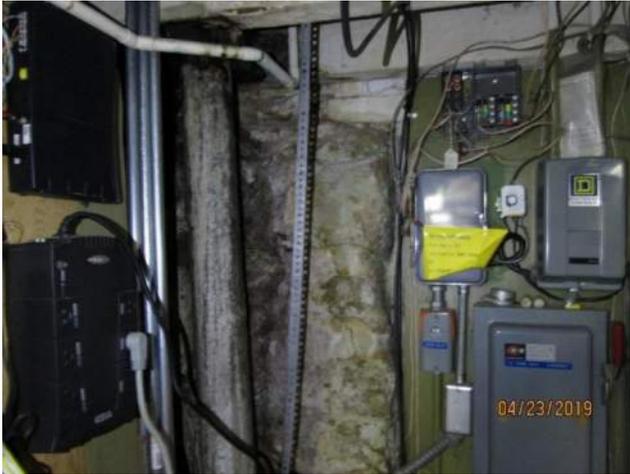
- The main electrical panels and IT equipment are located in the corner of the basement near a leaking roof drain creating a potential hazard safety hazard for anyone working on this equipment. (Reference Photo E1). The equipment is not rated for a wet environment.

E1 – Wall leaks at electrical panels

- Provide a dry, dedicated space with a door for main electrical and IT equipment.
- Replace all the main electrical equipment and devices with new and verify grounding of all equipment is in compliance with NEC requirements. Document layout of the new system through the development of a one-line diagram and by labeling all panelboard schedules.

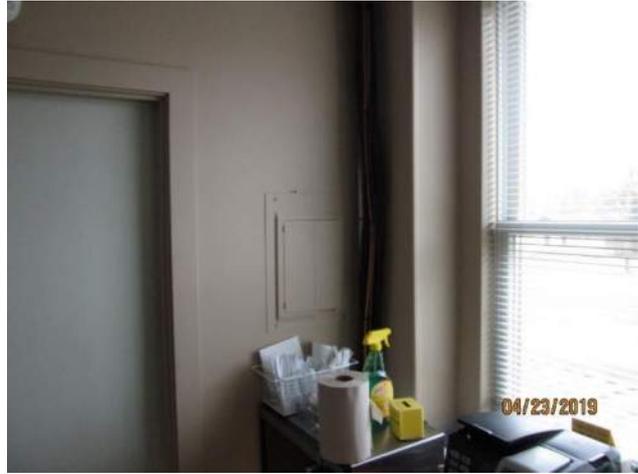
E2 – Sub-Panel

- Replace the subpanel in the kitchen with a new panel in a new location that meets NEC installation requirements. Demolish existing circuit conductors and provide all new conductors from panel to associated loads.

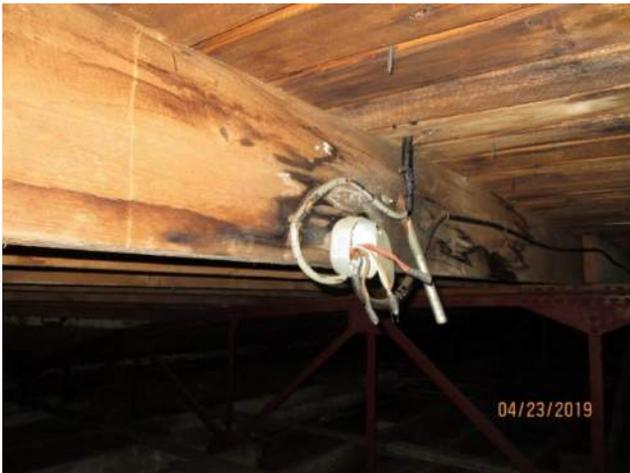
E3 – Knob and tube, open junction boxes

- In unfinished areas (attic, basement, etc.), all power wiring not installed in conduit that is exposed (i.e. romex, knob and tube, metal clad cable, etc.), should be demolished back to its associated panel and replaced with conduit and conductors.

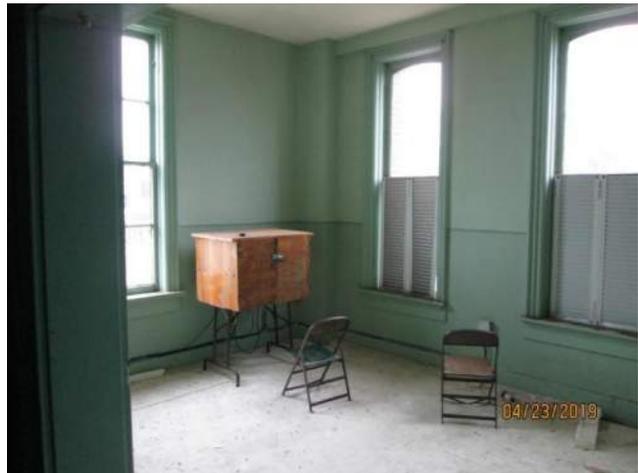
E4 – Exposed cables

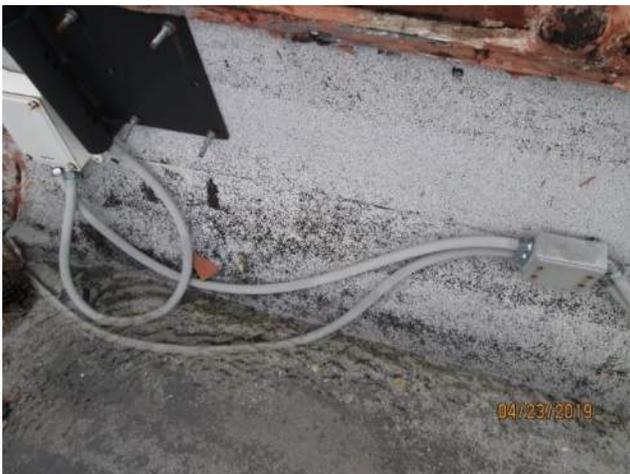
E5 – Exposed cables on roof

- Provide a fire alarm system for the building.
- Replace all emergency lighting (exit signs and egress lights) with new battery powered units.
- Replace conduit and cables on the roof with cables installed in rigid conduit supported on pipe stands. Any fittings or junction boxes shall be installed out of possible areas of flooding.
